3. SYSTEMS-RELATED ARCHITECTURE

4. ELEVATION SURVEY OF SETTLING

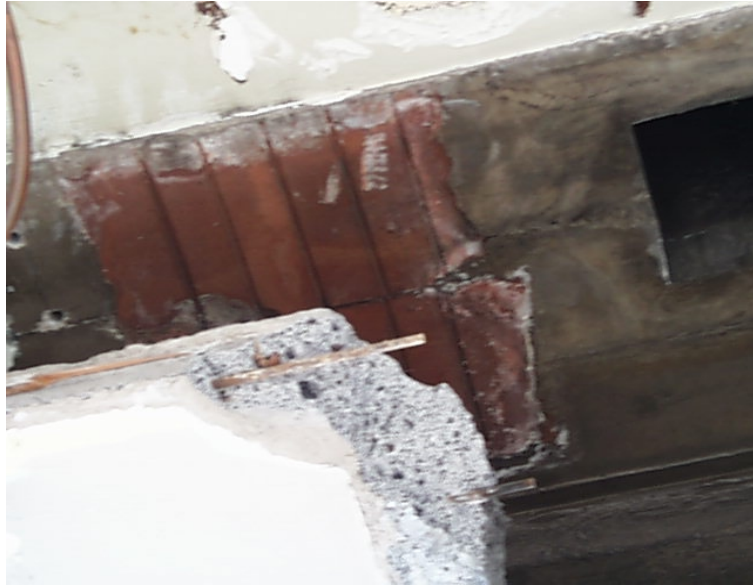
VIEW UP PILASTER, GROUND FLOOR UNDER CONSTRUCTION
